SO₂ Breakthrough under a Microscope

Optimized Gas Treating, Inc.

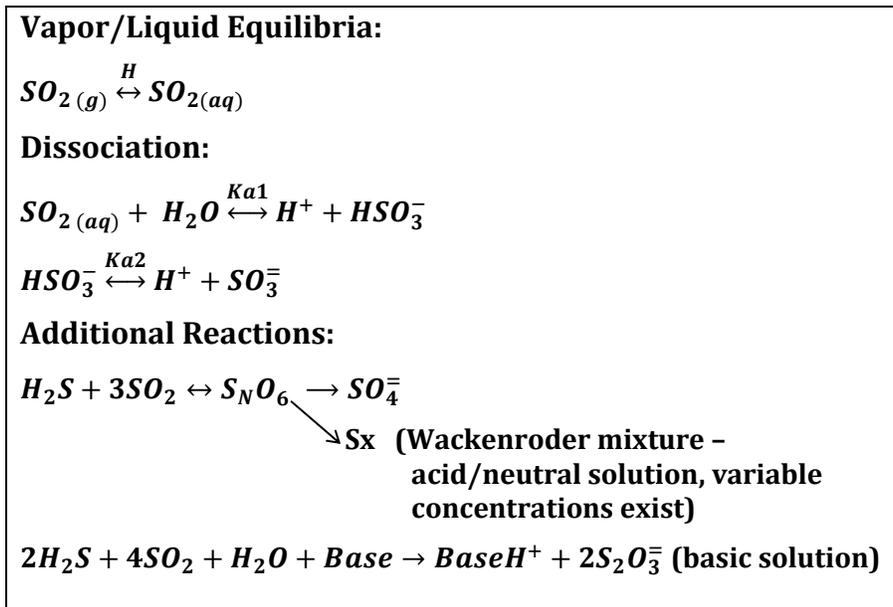
Table 1 SO₂ Breakthrough Simplified Chemistry

Table 1 shows the pathway and relevant chemical reactions that occur when SO₂ enters an aqueous solution. It is this chemistry that is responsible for the damage mechanisms described above.

- H₂S removal is no longer acceptable. The normal overhead concentration of 30-40 ppmv H₂S is now over 3500 ppmv!
- With H₂S present in the circulating amine, as long as the solution is kept basic, the sulfite can be expected to convert to thiosulfate over time as noted previously in Table 1. However, the kinetics of this conversion are not immediate by any means and are not well understood. In our opinion, it is not inconceivable that sulfite will survive and enter the Regenerator. Under the extreme case of no conversion to thiosulfate or elemental sulfur, ProTreat shows that some SO₂ will actually be present in the vapor inside the Regenerator with somewhere between 1-7 ppmv in the Regenerator Reboiler vapor return. Herein lies proof by simulation of a damage mechanism that was correctly postulated by Keller¹. The Regenerator reflux water could be almost as aggressive as the Quench Tower water if the breakthrough remains unchecked.

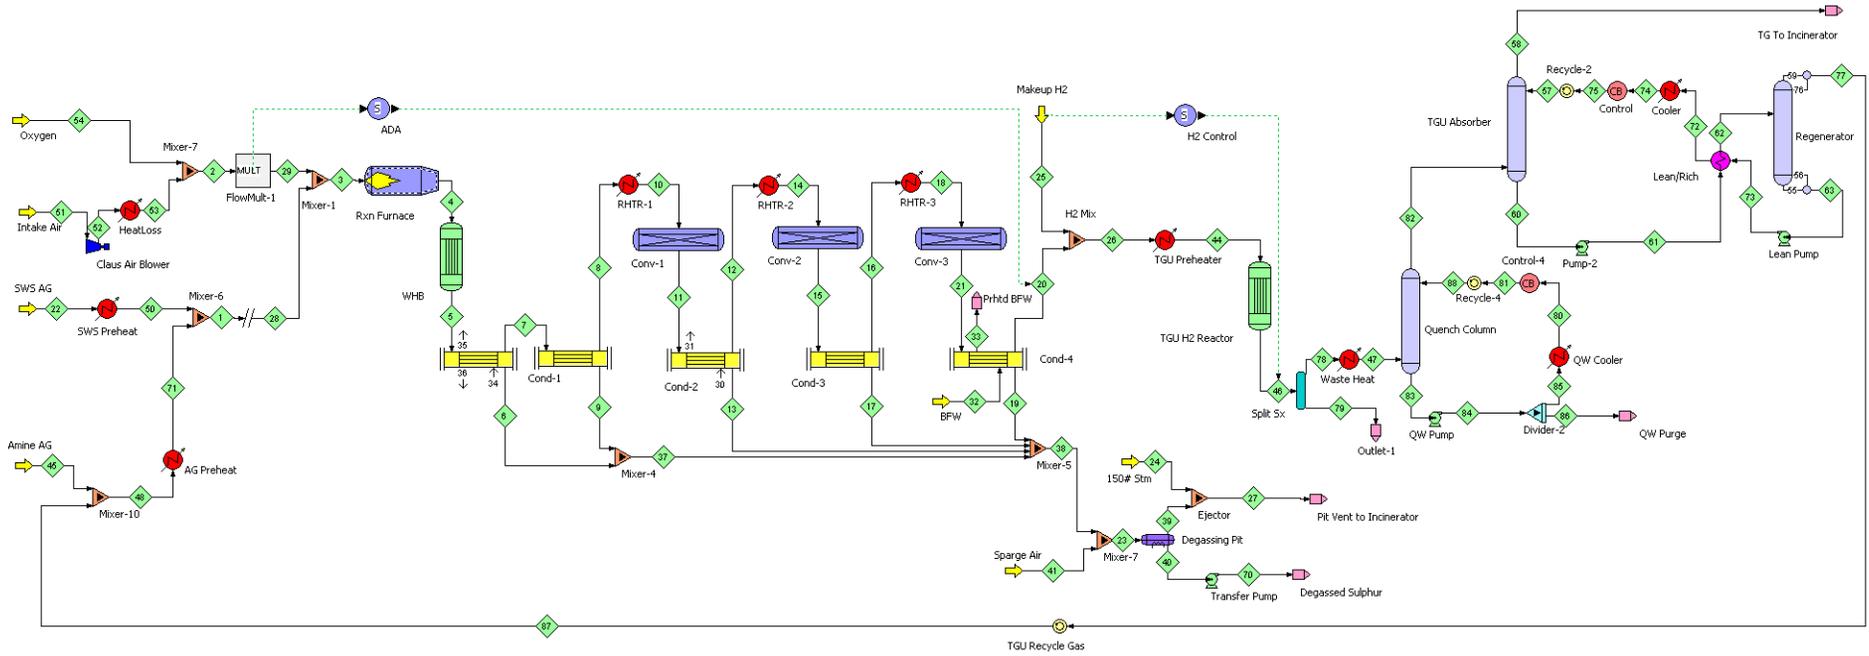
Figure 1 Claus/TGU Configuration Studied

The sample is prepared for the Microscope by setting some basic assumptions regarding the plant operation prior to the SO₂ breakthrough, i.e. when everything is “normal”. Figure 1 shows the overall flowsheet for the SRU/TGU train that was modeled, together with a few key plant details for the base case. The operating data and column details associated with this simulation are from a real operating plant. At the time of data collection, the Claus unit was operating towards the upper end of low-level oxygen enrichment. Consequently, there was plenty of excess hydrogen generated within the Claus unit itself from hydrogen cracking in the thermal section. The first column in Table 2 summarizes the critical key unit operating metrics for this operation and the more important parameters that were studied for the virtual SO₂ breakthrough.

One of the more common scenarios that can lead to an SO₂ breakthrough event results from either faulty or poorly maintained analyzers that are either ignored or placed in manual. The air demand analyzer (ADA in Figure 1) and Claus combustion trim air feedback control are perhaps the most important loops critical to keeping operational and in cascade control. The reasons will become quite evident after examining the case studies in this work. Within the TGU itself, the hydrogen analyzer (H₂ Control in Figure 1) is important to watch as excess hydrogen must be present to hydrogenate SO₂ and elemental sulfur to H₂S. Furthermore, the quench water pH analyzer can indicate when an SO₂ breakthrough is in progress so that mitigating actions can be taken.

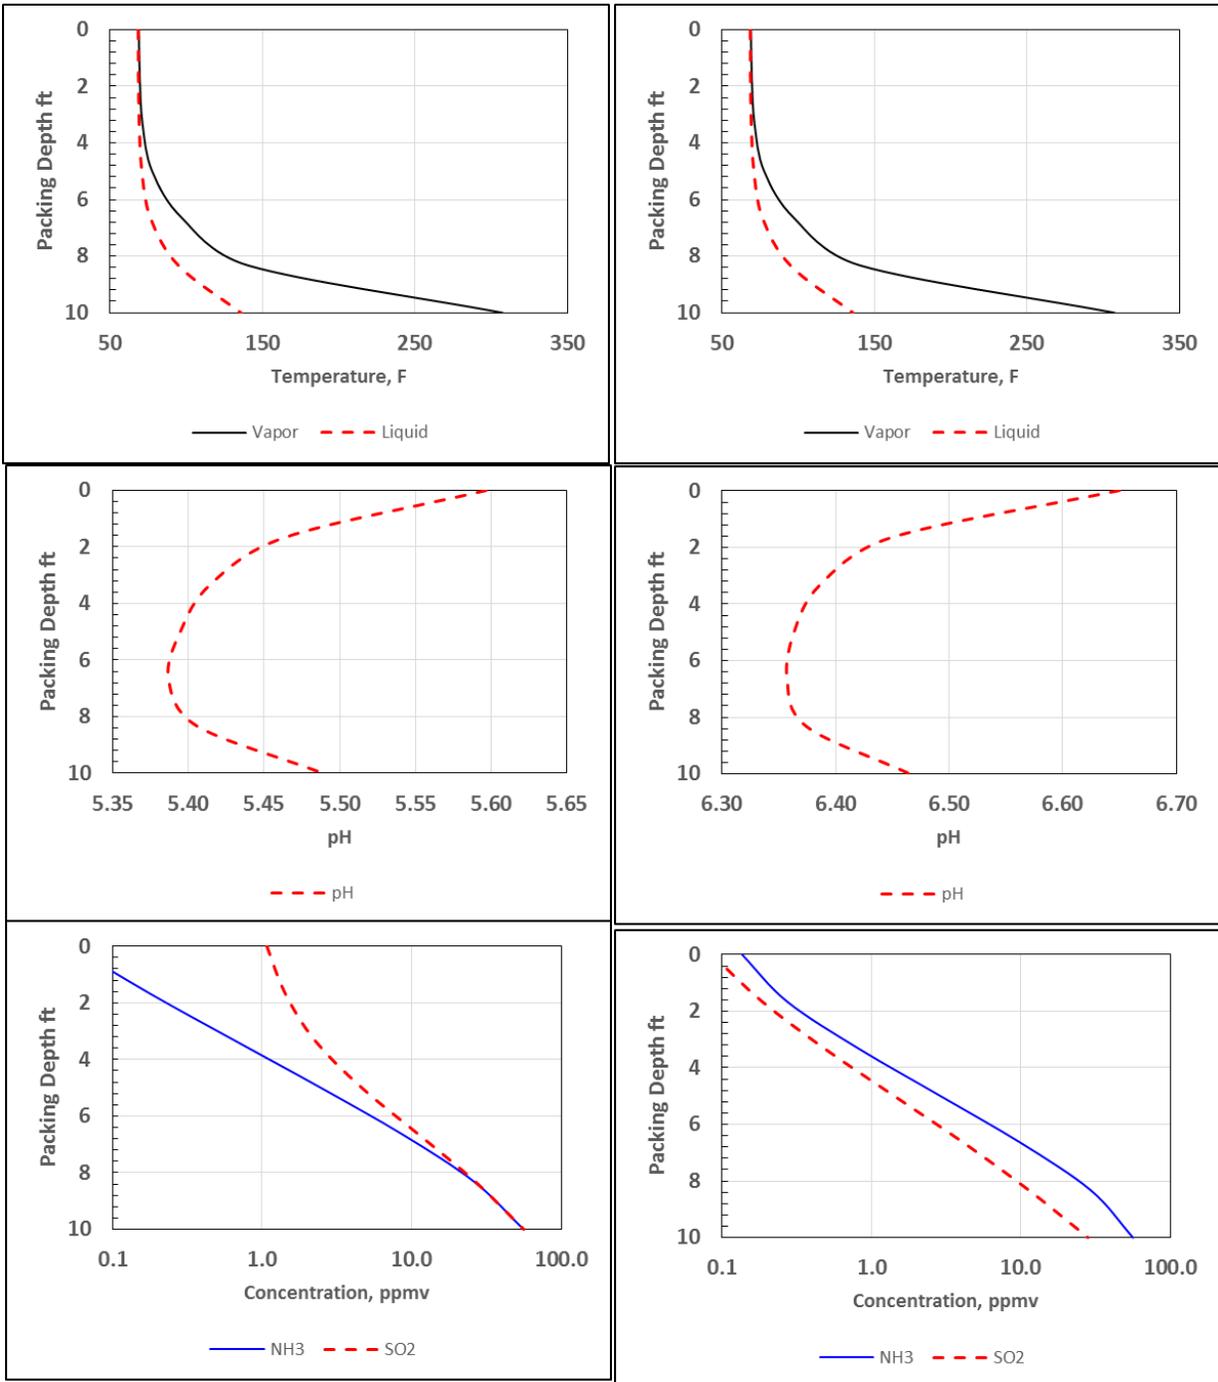
Figure 2 Quench Column Temperature, pH and Concentration Profiles

One of the key findings from the case study above was the importance of the ratio of SO₂ to NH₃ in the Quench Column feed. Because the SO₂ slip is so sensitive to excess air in the Claus unit, a second case study was performed to break the flowsheet at the quench column feed to allow the amount of SO₂ in the Quench Column feed to be directly varied. In this second case study, the Quench Column itself was examined under a 1:1 and 2:1 ratio of ammonia to SO₂. Figure 2 shows profiles of temperature, pH and vapor concentration of SO₂ and NH₃ across the Quench Column for a 1:1 ratio of NH₃ to SO₂ (left plots) and with excess ammonia at a 2:1 NH₃ to SO₂ ratio (right plots).

The temperature profiles in Figure 2 appear to be nearly identical for the two ratios studied. However, the pH for the 2:1 ratio of $\text{NH}_3:\text{SO}_2$ (right side) is nearly an entire pH unit higher. This allows the SO_2 to be removed to less than 0.1 ppmv. The learning here is that danger for an SO_2 breakthrough may be increased at pH levels below approximately 6.5 for this particular plant. There is no guarantee, however, that SO_2 is present if the pH drops to below this figure. The normal pH equilibration level for this particular system is 7.4-7.5 at the oxygen enrichment level that was in operation when the data was collected. The normal equilibration can be quite different for different operating conditions and for different units, so this is a situation where generalizations cannot be reliably made. Guidelines for caustic or ammonia injection neutralization targets can be constructed by running simulation case studies *for a specific plant's feed conditions and installed hardware* using the ProTreat® simulator.

With the 1:1 $\text{NH}_3:\text{SO}_2$ ratio (left side Figure 2), about 1 ppmv SO_2 slips into the amine system. So is 1 ppmv SO_2 really bad? Since SO_2 tends to stay in the liquid water phase, a little SO_2 in the feed vapor can result in surprisingly high levels of SO_2 when the circulating amine has come to steady state. Consequently, the recycle convergence tolerance for SO_2 breakthrough simulations usually has to be considerably tighter than for other simulations. After allowing 1 ppmv SO_2 in the feed vapor to build up in the amine loop in our virtual model, the SO_2 had accumulated to about 0.3 mole% or an equivalent loading of 0.041 mole/mole MDEA. The H_2S in the treated gas was still at acceptable levels. We can conclude that the amine system performance would decline somewhere between a 1:1 and 1.3:1 ratio of SO_2 to NH_3 (note the inverted definition) by considering these results together with the case study in Table 2.
